BROWN & GAMMONS LTD

MG T-SERIES TACH REDUCTION GEARBOX (27H210) INSTRUCTIONS AND ADDITIONAL INFORMATION

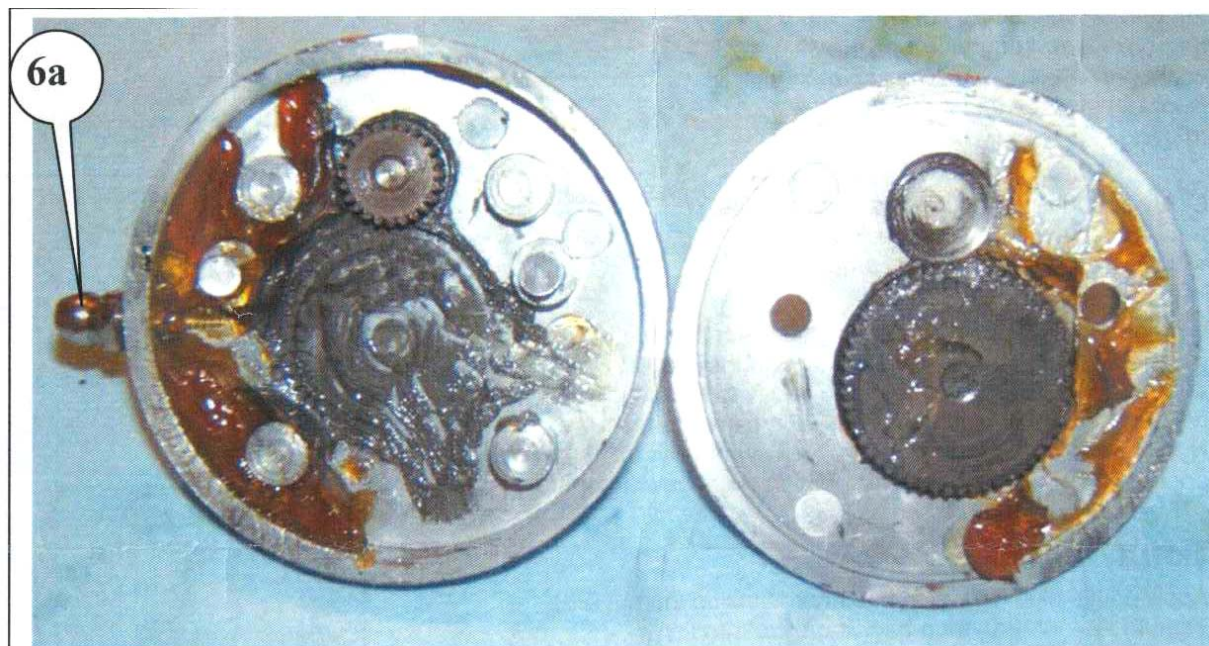
The gearbox (27H210) is a high quality reproduction of the original item. When they are assembled, the manufacturer injects grease inside the case through the grease nipple (6a).

Over time the grease will thicken and when you first try and turn the shaft (5c) you will feel some resistance. It may even seem that the gearbox is 'frozen', or locked up solid. Having inspected and disassembled quite a few of these, we know that the stiffness is the grease.

Once broken loose, the shaft will turn, and it gets easier as the grease gets spread around the inside of the housing. If you wish, you can use an electric drill to spin the shaft for a minute. Then try it by hand. You will find the shaft rotates easily and smoothly,

This is why we recommend that you check the tach reduction gearbox as an assembly out of the car to make sure the cable spins freely, and that it drives the tach reduction gearbox smoothly. Once you are satisfied that the gear reduction box is operating as it should. Please review the information we have included on page two for solutions to potential installation problems prior to installing this unit.

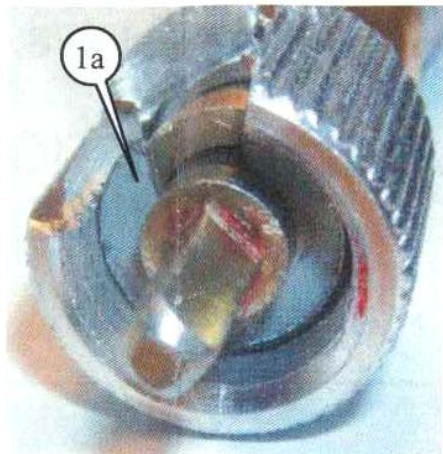
Found only with the OE style cable. The cable manufacturer currently uses a circlip (1a) to retain the inner cable in the housing. When attached to the tach reduction gearbox (2a), the circlip (2c) bottoms out against the end of the tach reduction gearbox (2e) when the nut on the cable (2d) is tightened. The cable is locked in place and it cannot rotate.

Oddly enough, this situation does not exist with the replacement type cable, which is made by the same company.

Apply a little blue Loctite to the threads inside the nut (2d).

Tighten the nut (2d), then back it off two turns.

Leave it overnight to allow the Loctite to cure.
